Toshiba Equium M70 Faulty Graphics

This will fix the dreaded graphics driver issues, when windows says the driver has stopped responding. The problem is caused by a very thin heat sink on the GPU, with little to no thermal paste, when the chip heats up the thin heat sink expands & concave

Written By: Terry Sim

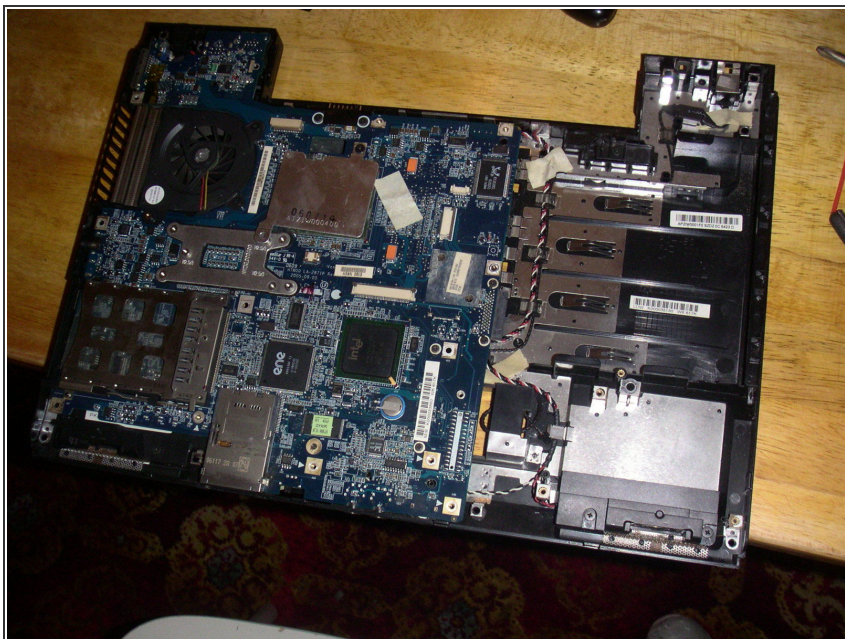
Step 1 — Toshiba Equium M70 Faulty Graphics

- This is a complete top half strip down to fix (takes me less than 30 minutes)

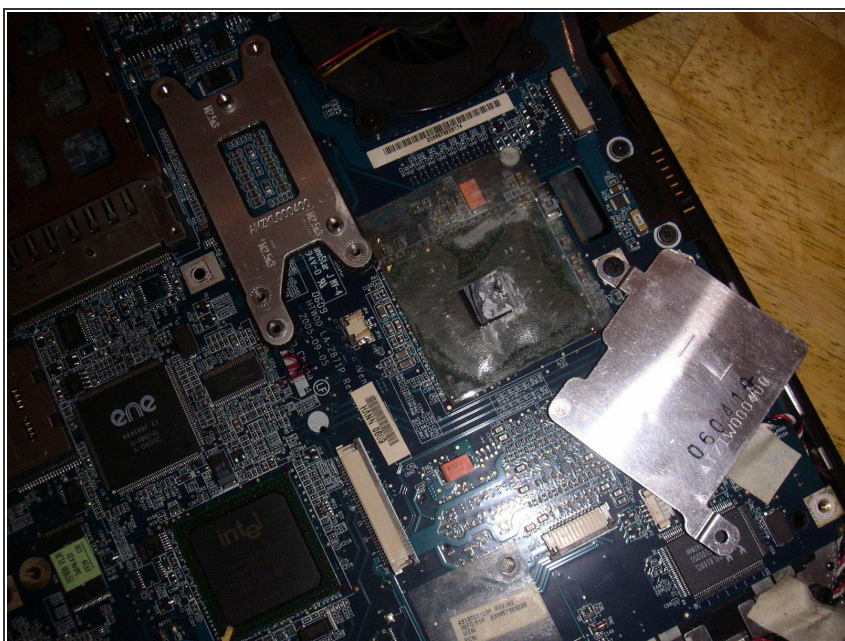
Step 2

- this is the culprit, as you can see the shim can easily overheat & go concave lifting off the chip.

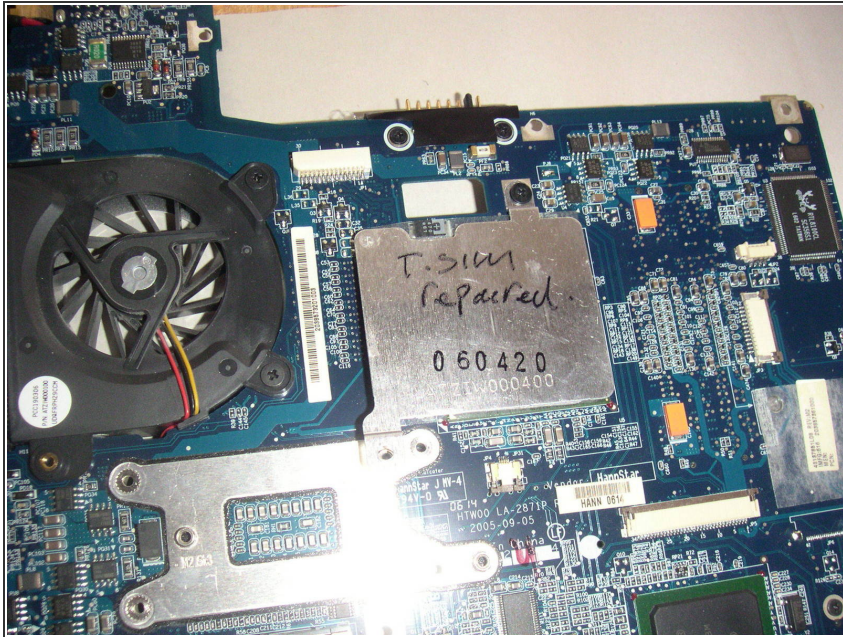
Step 6

- The new alloy shim is under the existing thin shim. I've done more than 20 of these repairs & had 100% success rate I always do the same to the CPU (might as well your already in there).,
